Preliminary Engineering Report
Market Street Tower 2010
City of Vermillion, SD

Prepared By
Banner Associates, Inc.
Brookings, South Dakota

August 2010

*MARKET STREET TOWER IMPROVEMENTS
PRELIMINARY ENGINEERING REPORT-2010
CITY OF VERMILLION
TABLE OF CONTENTS*

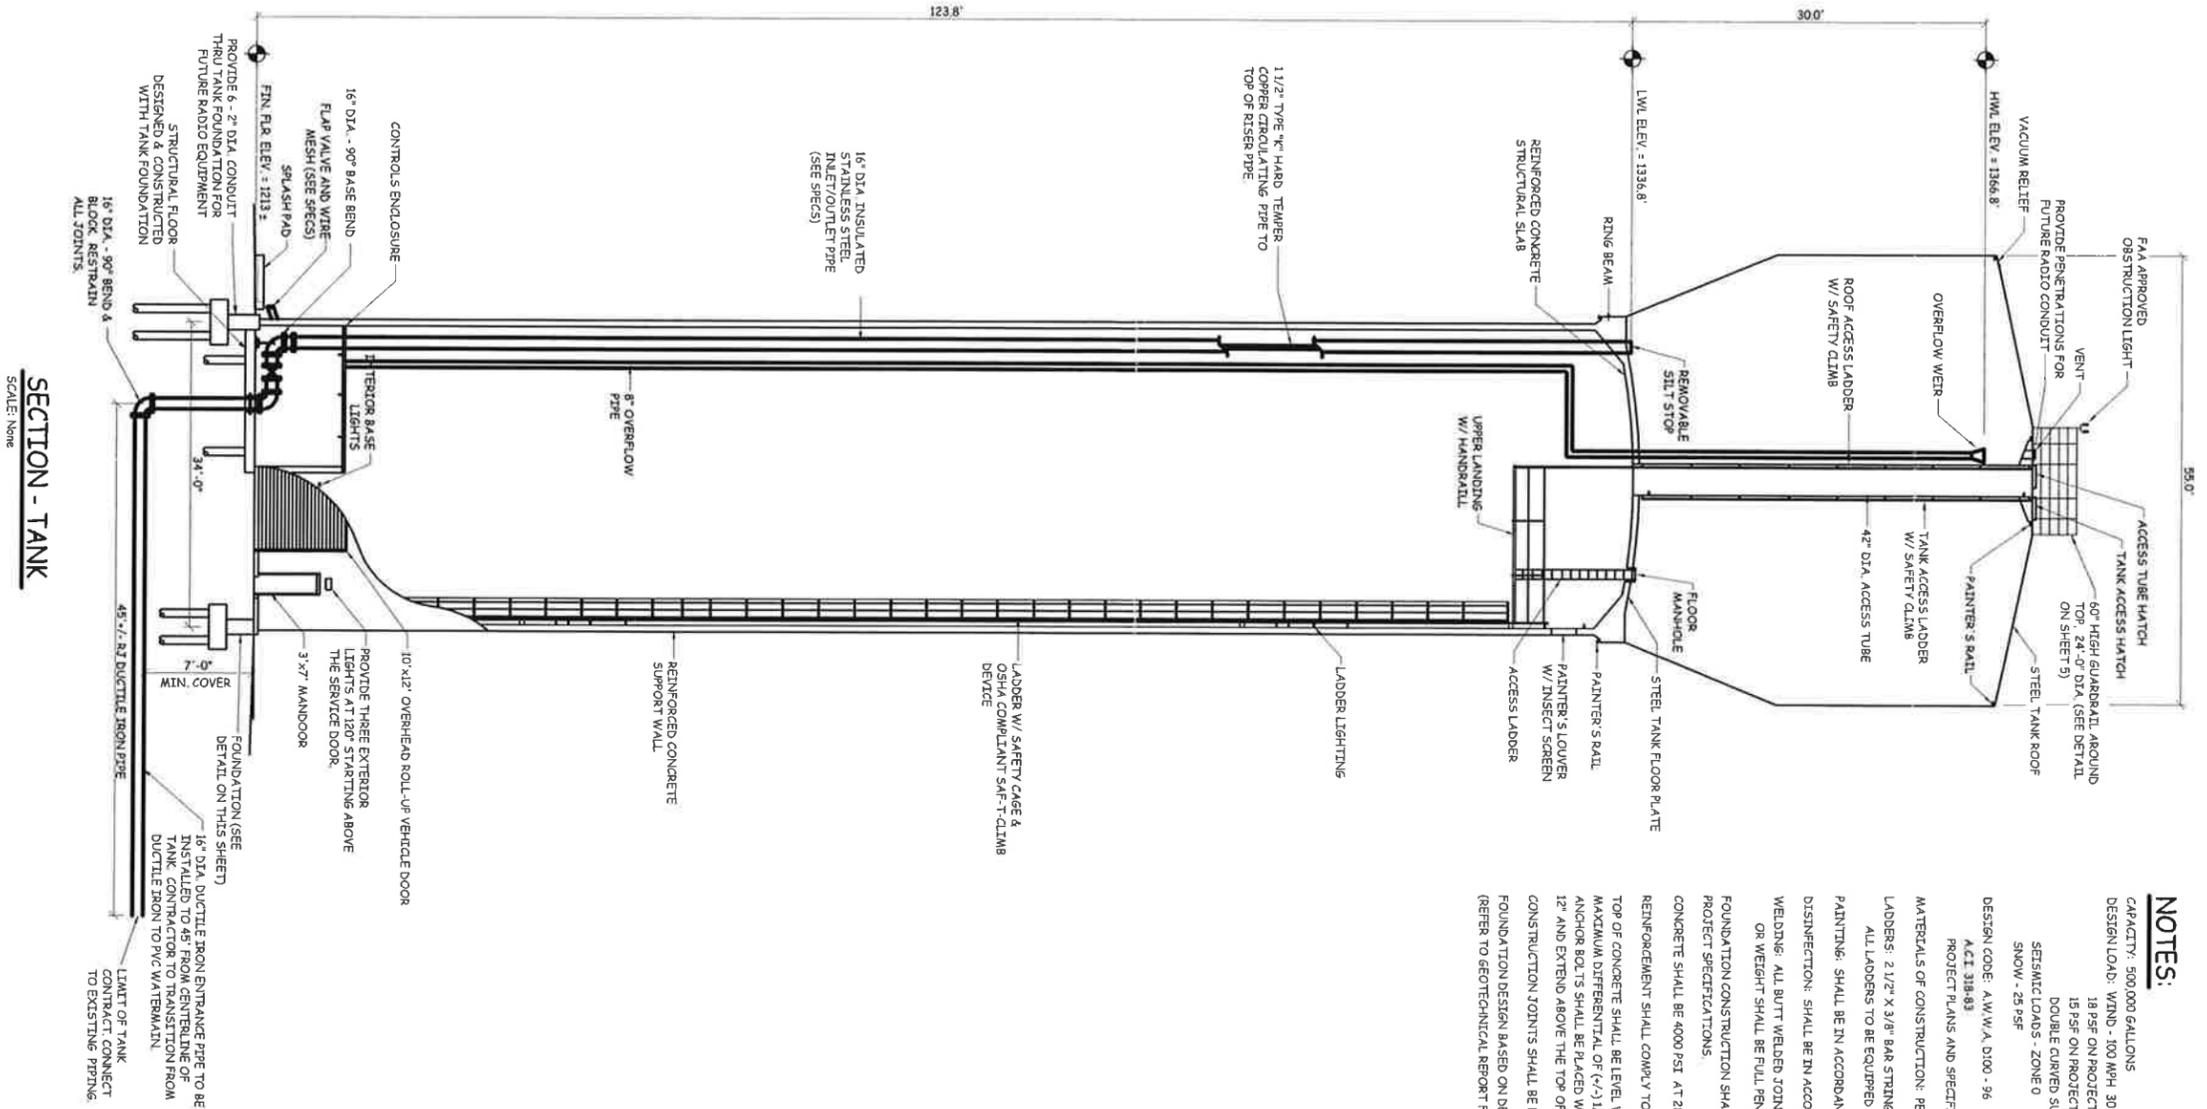
FIGURE NO.:
FIGURE 3.1

SHEET TITLE:
COMPOSITE STYLE WATER STORAGE TANK

SECTION - TANK
SCALE: NONE

The City of Vermillion has indicated a preference for a composite water tower. The composite water tower is preferred because the O&M costs for painting and repairs are less than either a fluted column or spheroid, which is primarily due to the lower surface area required to be painted. The capital costs for either type of tower is approximately the same. The base of the composite tower also offers more storage and floor space than either a fluted column or spheroid. Figure 3.1 shows a typical elevation for a composite water tower.

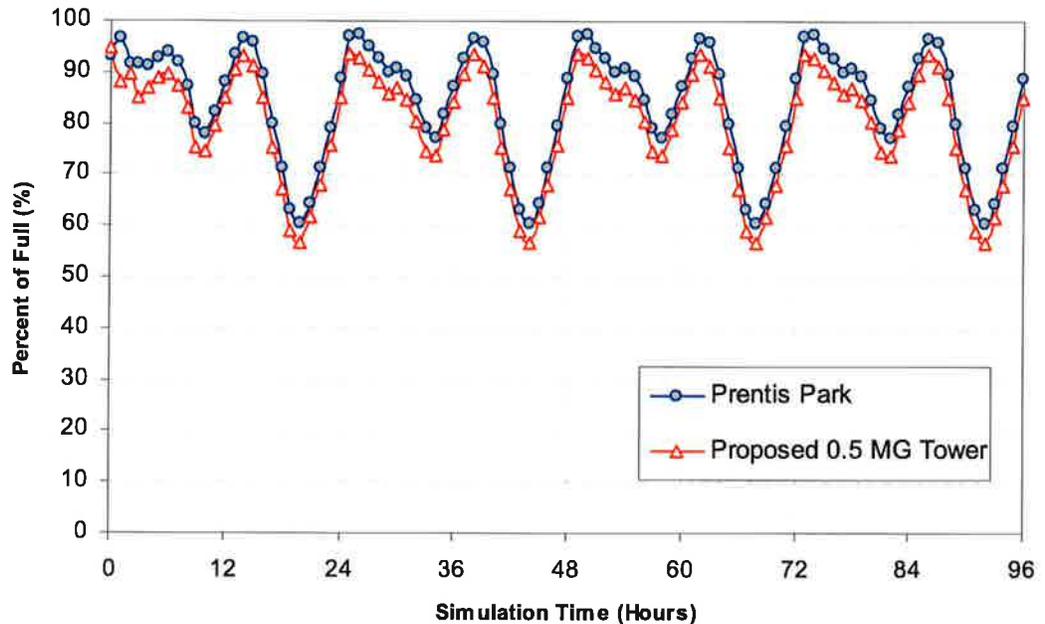
Figure 4.2: Water Levels in Prentis Park and Proposed 500,000 gal Towers

Figure 4.2 shows that the water levels in both the Prentis Park Tower and the new Shriner Street Tower cycle together. Adding the tower to the north part of town creates better hydraulic connection between the two water towers. Available fire flow rates were also checked to verify what effect moving the water tower would have on existing levels of fire protection. Available fire flows were greater than the existing fire flows in the north area of town.
